CHICHESTER POP UP CYCLE SCHEME

Stage 3 Road Safety Audit

PROJECT NO. 70073305-RS3

DATE: SEPTEMBER 2020

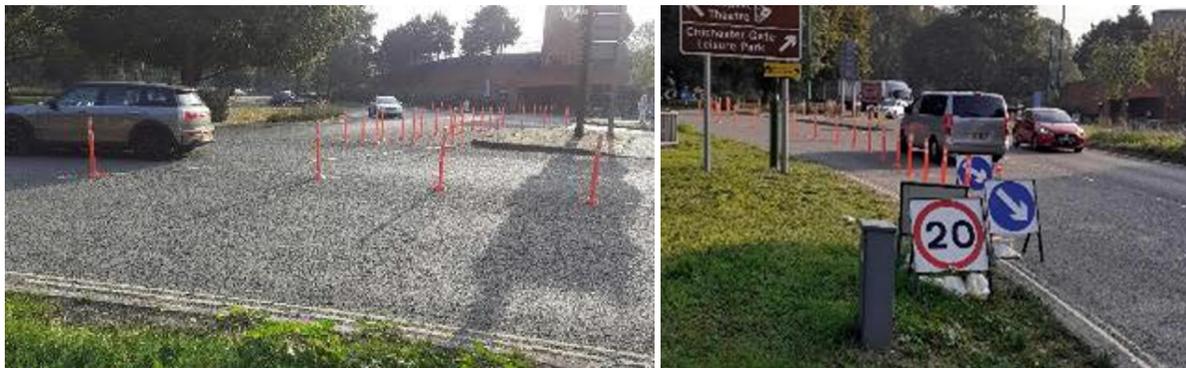
The orange cylinders that have been used throughout the scheme are used to create areas where cyclists are segregated from traffic, and to create areas where cyclists are not permitted and should share the narrowed road space with other traffic.

During the site visits it was observed that neither the cyclists or other road users were clear on the intention in the areas where cyclists were not intended to go. Frequent conflict and verbal abuse of cyclists was observed at these locations.

“COVID Pop Up Cycle Lane Ahead” signing has been used on the approach to areas where cyclists are not permitted, further confusing matters.

Cyclists were observed on site to slow down in the circulatory carriageway to enter between closely spaced wands on the outside of the circulatory carriageway that were not intended for cycle use.

This could result in collisions between cyclists and other vehicles, or aggression towards cyclists whereby they might hesitate and collide with each other, or fall off.

Areas not intended for cycle use, Via Ravenna

It is recommended that areas not intended for use by cyclists are closed with a solid barrier.

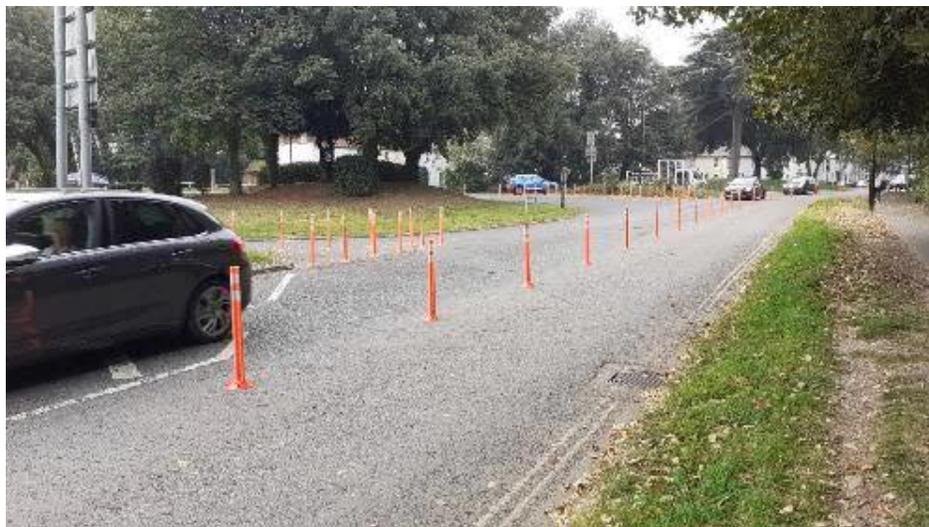
No specific entry and exit points are provided at the roundabouts throughout the scheme. All of the cylinders are the same colour and spacing and from the driver / rider view point it is difficult to identify the intended route for cyclists.

Examples of this are where gaps are provided for cyclists to turn right to leave the lane or to cross a roundabout exit arm, and where cyclists join the cycle lane from a roundabout circulatory carriageway.

Drivers may fail to realise that cyclists must pull out around any signing within the taper in order to join the lane, resulting in side-on collisions with cyclists, or shunts between following vehicles.

Cyclists stopping to turn right may be hit by other following cyclists. Cyclists proceeding along a lane through a roundabout may fail to negotiate with a cyclist entering from a roundabout, resulting in one of them falling.

Cyclists may hesitate in the circulatory carriageway deciding which gap to use to enter the cycle lane, causing other vehicles to brake hard, resulting in shunts.

Cyclists entering the lane from a roundabout at a difficult angle may fail to turn, hitting the kerb and falling off.

Lack of clarity between areas intend for cycle use, areas closed off, exit point from circulatory carriageway to cycle lane, and intended route for cyclists heading to New Park Road.

It is recommended that all entry and exit points are marked with a different colour wand to help all road users identify appropriate gaps and anticipate each other's path.

It is recommended that give way triangles are placed in advance of the marked gap so that cyclists proceeding along the lane give way to those joining from the roundabout circulatory areas.

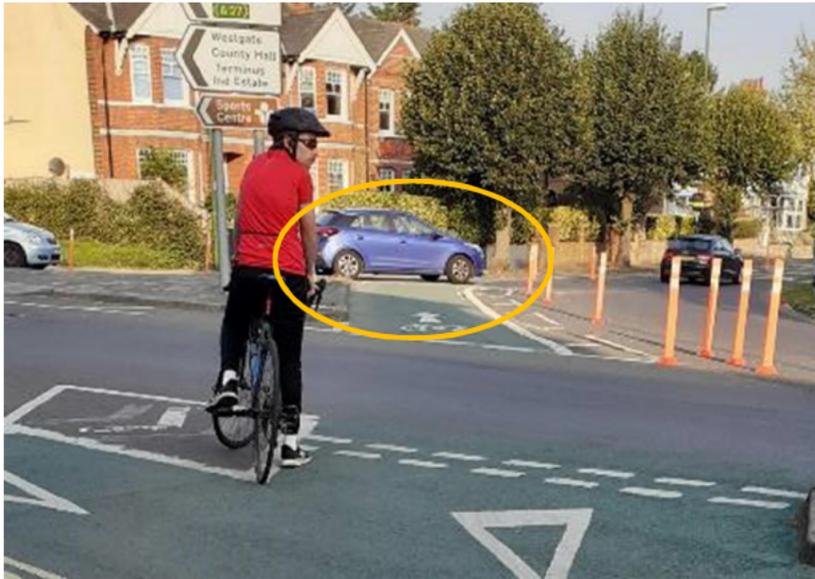
The line of cylinders forming the edge of the cycle lane across entry points to roundabouts infers that the give way line has been pulled forward to the edge of the vehicle carriageway. This could result in drivers overshooting the give way line into the cycle lane where cyclists could ride into the side of them and be thrown from their bikes.

Car giving way at the edge of the cycle lane rather than in advance of it

It is recommended that the Give Way markings are refreshed on all approaches where the cycle lane continues around roundabouts and signs are provided to advise Drivers to Give Way to pop up cycle lane at the give way line.

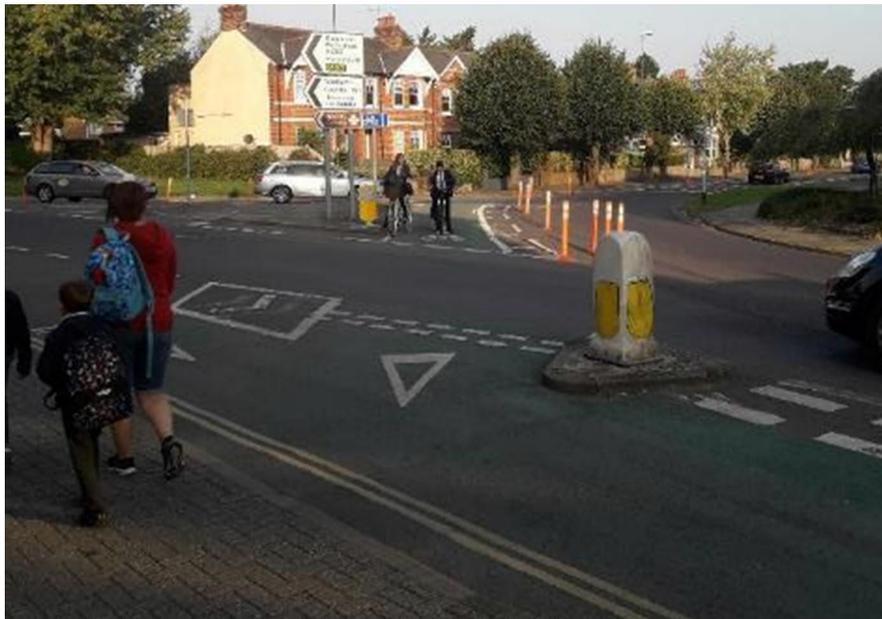
Cyclists were observed going against the direction of traffic within the cycle lane. Although there were low volumes of cyclists within the lane itself, there is no indication for drivers that cyclists are likely to be crossing the junctions from both directions and they are unlikely to look to their left to check for cyclists going the wrong way. This could result in cyclists being struck by vehicles at the junctions.

At points where the existing islands restrict the width of the lanes, there may be conflicts between opposing cyclists.

Cyclists using the lane in contraflow

It is recommended that specific desire lines are identified where it would be beneficial to allow contraflow cycling and provide additional signing and road markings to promote safe use of the cycle lanes in contraflow.

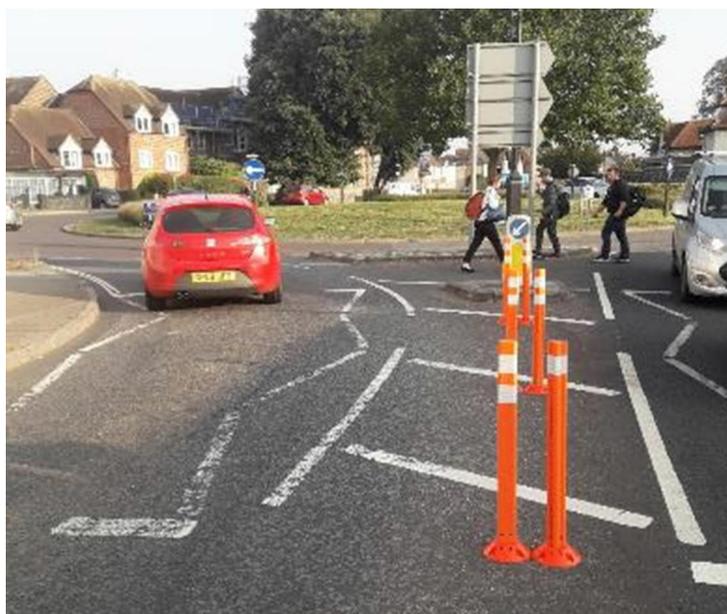
The cycle lane terminates on the approach to the roundabout, and the central cylinders continue in a straight line up to the central island. The existing hatch markings that direct drivers around the splitter island at the roundabout are still present, but drivers are now expected to drive over them.

This guides drivers to merge left at the point where cyclists no longer have protected space. This could result in side swipe collisions between cyclists and other vehicles.

The revised alignment for other vehicles does not guide them around the splitter island. The only other guidance is the keep left bollard on the small island, which is set back a long way from the kerb of the splitter island and may be hidden from view by the cylinders. The realignment of the traffic lane could result in vehicles striking the island, or sudden manoeuvres to avoid hitting it, resulting in shunts.

Wands and hatching on the approach to central island on Avenue de Chartres

It is recommended that the existing hatch markings and zig zags are removed and realigned to properly indicate the vehicle approach to the island and discourage drivers from “squeezing out” cyclists, with additional cycle logos provided up to the give way line.

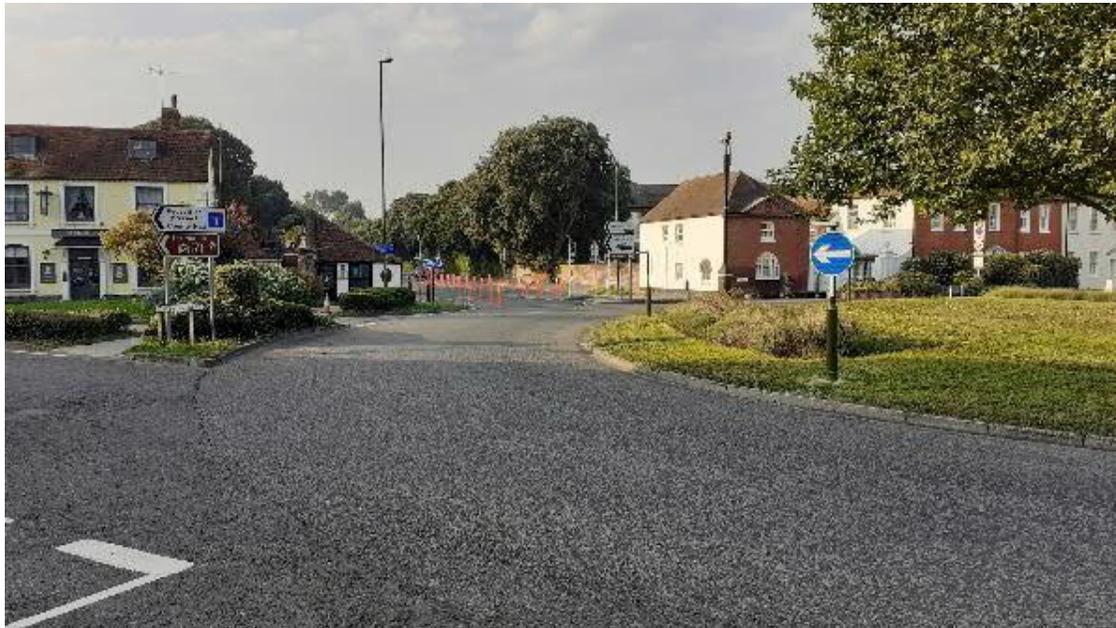
A temporary pop up cycle lane bounded by wands has been provided on Avenue de Chartres in a southbound direction from Westgate Roundabout. Cyclists using the roundabout were observed to take a primary position which discourages vehicles from overtaking and encourages cyclists away from the entry arms, providing increased visibility to / from the cyclist.

The location of the wands on the exit arm require a cyclist to align themselves closer to the outside of the roundabout which may lead to reduced visibility of the cyclist from West Street resulting in collisions. Cyclists may change direction to enter the cycle lane on the circulatory carriageway and following vehicles may not anticipate this, leading to side swipe collisions.

Wands on exit arm of Westgate roundabout to Avenue de Chartres

It is recommended that the first wands on the exit arm are removed.

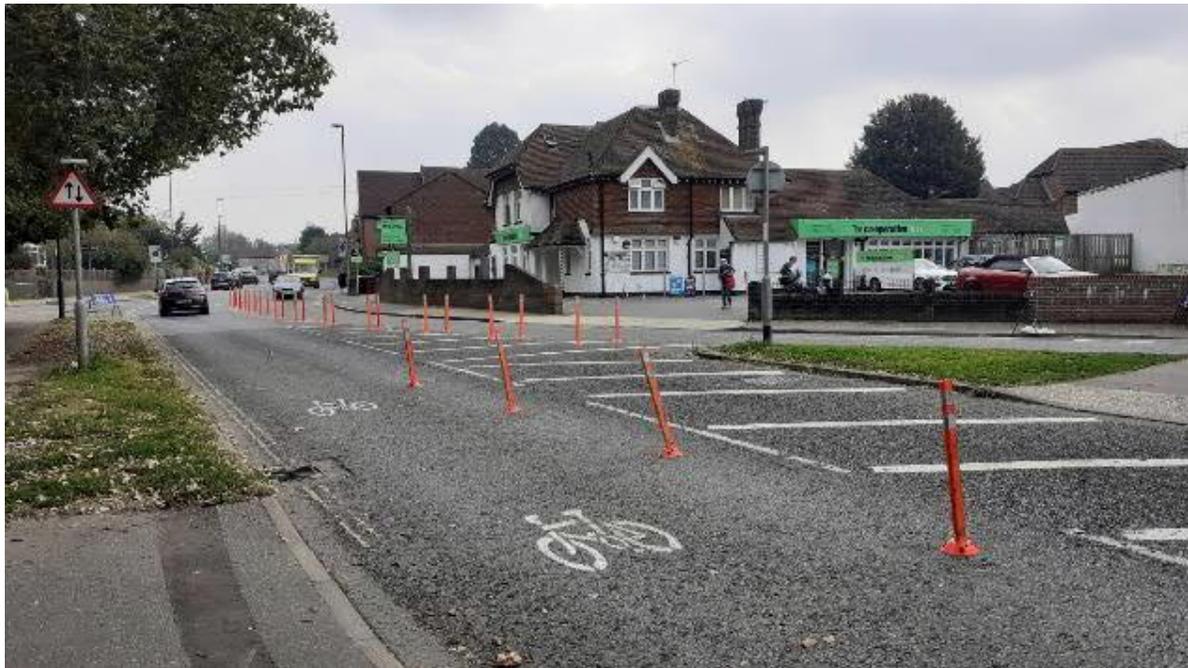
The exit from the Oaklands Way Roundabout onto Spitalfield Lane has previously been reduced to a single lane by providing hatching on the offside, in order to create a right turn pocket for vehicles entering College Lane. The provision of the cycle lane has meant that the general traffic lane now passes over the hatching, which has not been removed.

At the end of the splitter island the cylinders forming the cycle lane end, and additional cylinders on the centre line guide vehicles to merge into the cycle lane. The lane marking forming the edge of the hatching could be construed as a give way line for vehicles merging left, giving cyclists priority. As this is not the intention, it is open to misinterpretation and some drivers may not expect the vehicle in front to stop, resulting in shunts. Some cyclists may believe they have priority over merging vehicles, resulting in side swipe collisions.

Hatchmarking in general traffic lane, Spitalfields Lane

It is recommended that the hatch marking and lane marking are removed, and additional, larger cycle logos are provided in the centre of the lane at the merge point, and a sign is provided on the splitter island indicating “cyclists merging from the left”.

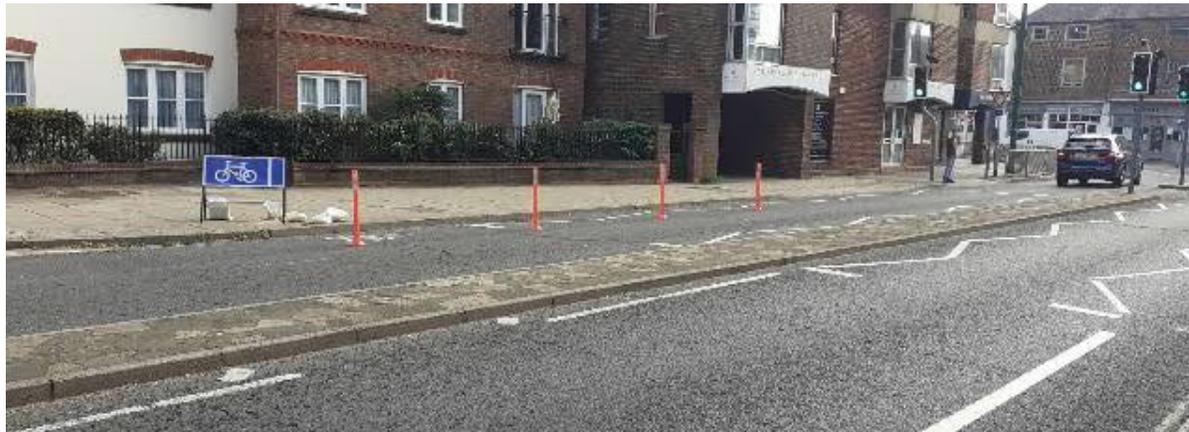
The cycle lane in Avenue de Chartres breaks in advance of Deanery Close to provide for the left turn into the car park, and then continues for a short length in advance of the pelican crossing, where it breaks again for a vehicle access. Downstream of the crossing the road is marked as 2 lanes, both turning left into Southgate. At the junction with Market Avenue and South Street, both lanes turn right into Market Avenue so cyclists will need to be in a primary position in lane 1 to make this turn. The cylinders downstream of Deanery Close may restrict their ability to do this.

Vehicles heading towards South Street are likely to merge left ahead of the south street junction, restricting cyclists ability to take up a primary position.

There are no cycle markings after the cylinders to remind drivers to make room for cyclists.

This could result in cyclists being hit by other vehicles, or being “squeezed” on the approach to the junction, causing them to fall.

The width of the pop up cycle lane is restricted due to the left turn out of Deanery Close and the central island. Cyclists entering the lane will need to travel closer to Deanery Close junction where they may be less visible to drivers exiting the junction. This may lead to vehicle / cycle collisions.

Cycle lane cylinders on the approach to Southgate

It is recommended that cyclist and driver interaction is observed over several peak periods, and if beneficial, the cylinders are removed.

It is recommended that a sign is provided on the central island indicating “cyclists merging from the left”, and additional, larger cycle logos are provided in lane 1 to indicate to drivers that cyclists are merging into general traffic.
